Manhole Inspection Summary

Manhole # S45C2_011MH

Location Address: **3800 Fairhaven Ave**

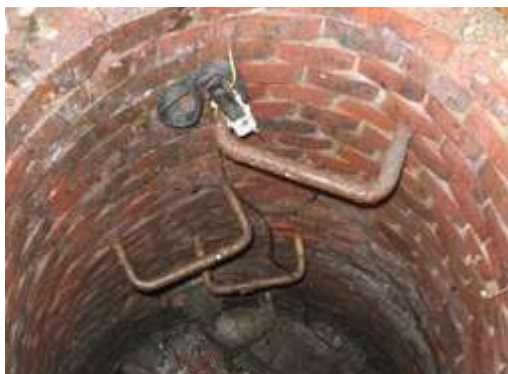
Steps

Count: **4** Missing: **0** ☐ Corroded

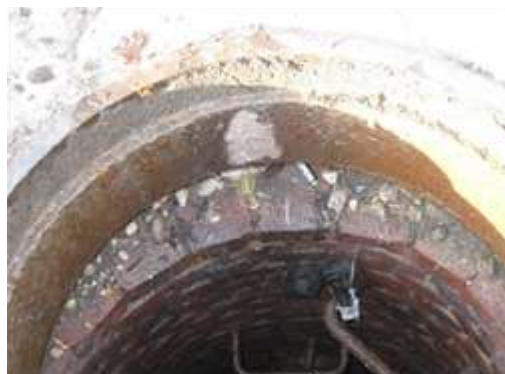
Defect 1

Offset: **2.5** (in.)

Frame offset

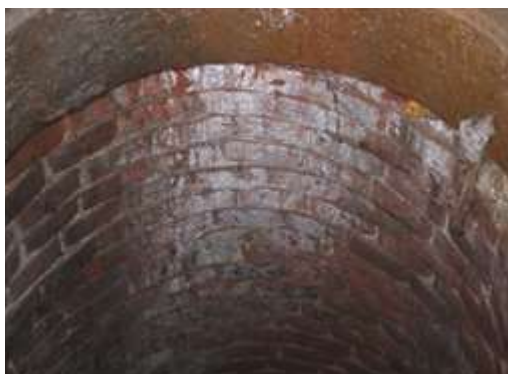
Defect 2

Infiltration: ☐ None ☐ Joint ☐ Cracks ☐ Mortar ☐ Roots ☒ Wall

Wall

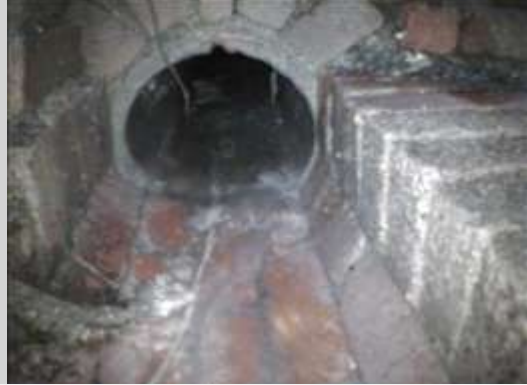
12 O'Clock Outflow

8 in. Circular Gravity Sewer
Pipe Out @ 12 O'Clock

Pipe Height: **9.6** (in.) Rod and Bar (Angled)
Pipe Material: **Clay** ☐ Pipe Lined
Invert Depth: **10.29** (ft.) Flow Characteristics: **Fast**
Deposits: ☒ None ☐ Mud ☐ Sludge ☐ **Debris** ☐ Grease
Silt Depth: (in.) Deposits Extent:
Infiltration: **None** Pipe Seal Cond: **Sound**

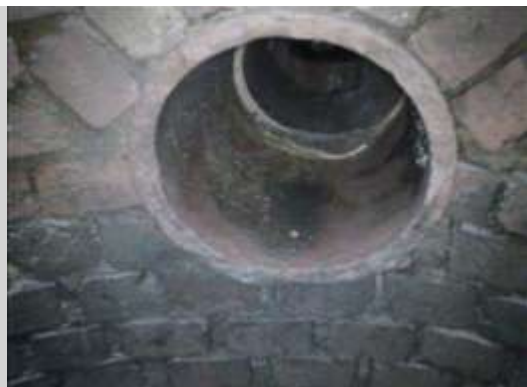
6 O'Clock Inflow

8 in. Circular Gravity Sewer
Pipe In @ 6 O'Clock

Pipe Height: **9.6** (in.) Rod and Bar (Angled)
Pipe Material: **Clay** ☐ Pipe Lined
Invert Depth: **8.00** (ft.) Flow Characteristics: **Fast**
Deposits: ☒ None ☐ Mud ☐ Sludge ☐ **Debris** ☐ Grease
Silt Depth: (in.) Deposits Extent:
Infiltration: **None** Pipe Seal Cond: **Sound**

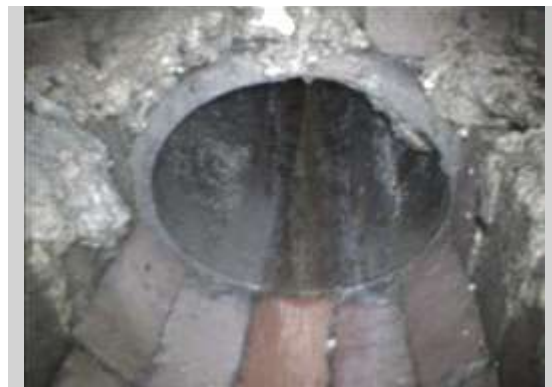
Pipe In @ 6 O'Clock

Drop: **Outside** Rod and Bar
Angled: **Yes** Reading: **8.94** (ft.)
Inv Depth: **9.94** (ft.)
Drop Condition: **Open**

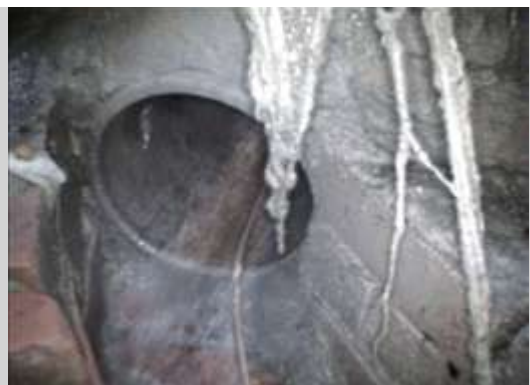
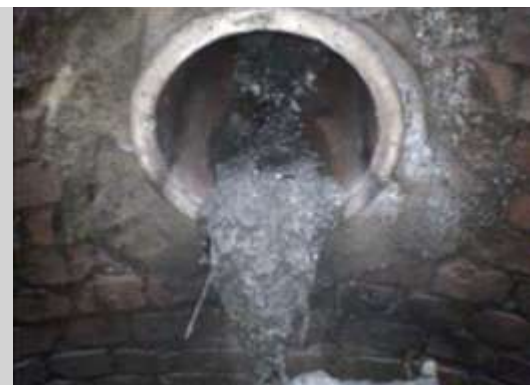
8 O'Clock Inflow

Deposits: ☐ None ☐ Mud ☐ Sludge ☒ **Debris** ☐ Grease

Silt Depth: **0** (in.) Deposits Extent: **Medium**

Drop: Outside	Rod and Bar
Angled: Yes	Reading: 8.37 (ft.)
	Inv Depth: 9.37 (ft.)
Drop Condition: Open
